QUARTERLY UPDATE

FOR OCTOBER 1, 1993 THROUGH JANUARY 1, 1994

HISTORICAL RELEASE REPORT (HRR)

EG&G ROCKY FLATS, INC

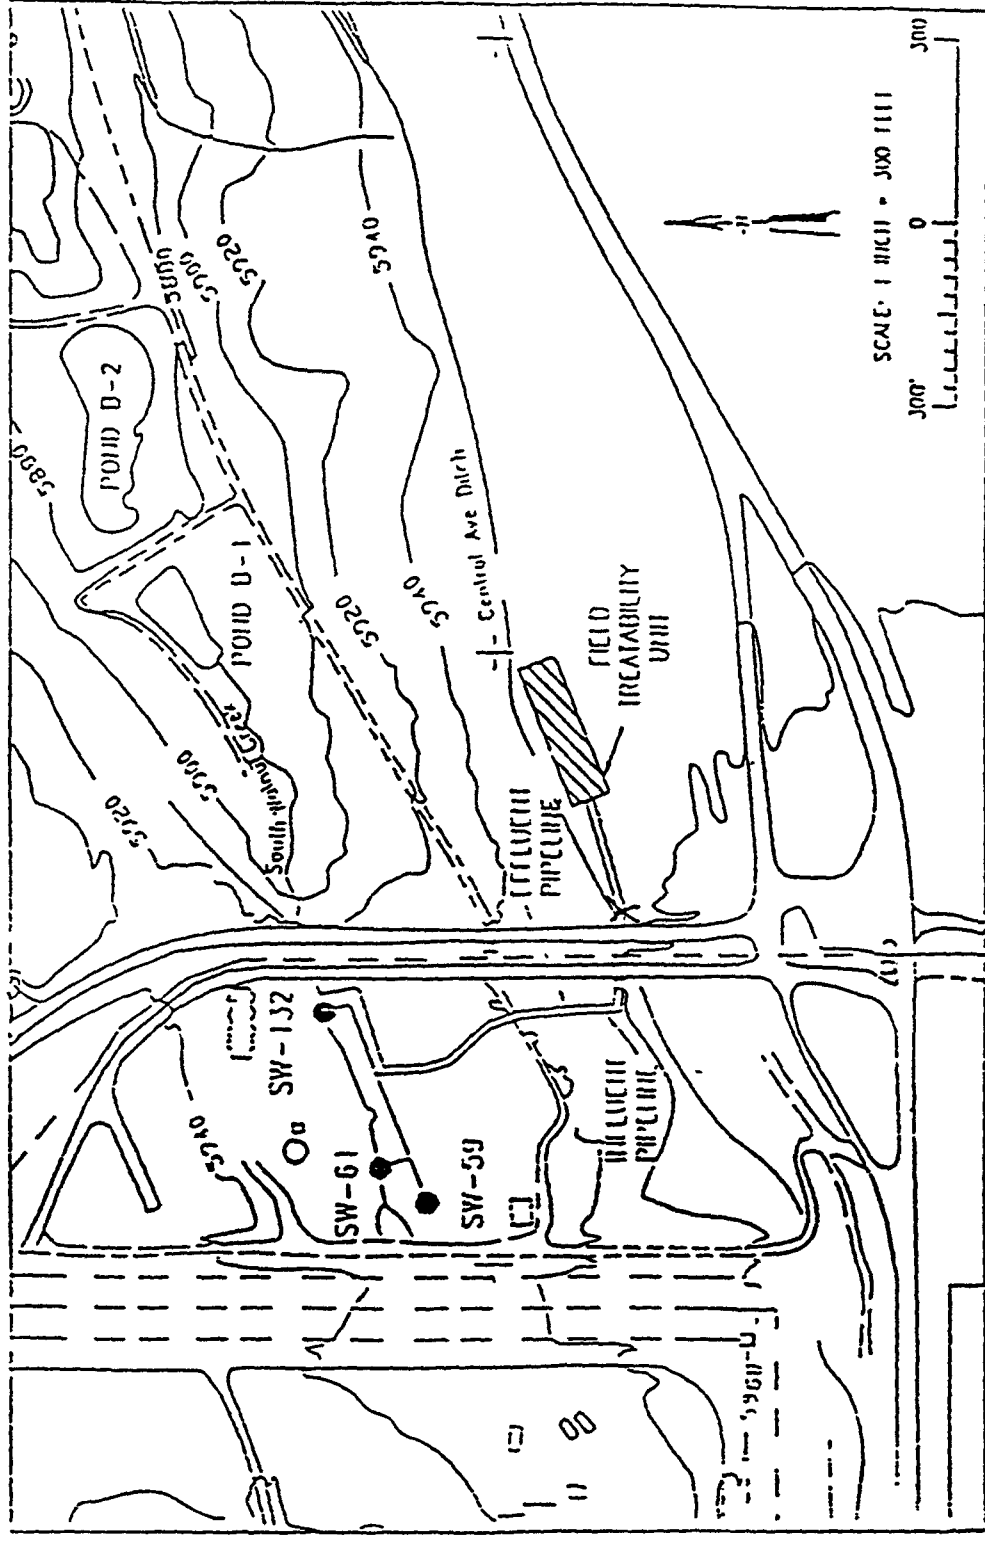
The release occurred at 2:30 pm, Saturday, December 4, 1993. A subcontractor employee discovered the release from an influent water line in response to an alarm signaling that a release had occurred. The contractor noticed a slow leak coming from a connection in the secondary containment portion of the influent pipeline. The primary pipeline was found to be leaking from a hole in the line. The estimated amount of material released to the environment is 10 gallons by visual determination of the size of the wetted area. Constituents found in the contaminated water support the fact that the contaminated water is an "F001" listed hazardous waste.

X approx location of leak/spill

The system was repaired and returned to normal operation on December 8, 1993. The daily inspections of the pipeline are continuing.
